Proximal Hamstring Repair

A Biomechanical Analysis of Variable Suture Anchor Constructs

Michael B. Gerhardt,^{*†} MD, Benjamin S. Assenmacher,[†] MD, and Jorge Chahla,[†] MD, PhD
Investigation performed at the Arthrex Biomechanics Laboratory, Naples, Florida, USA

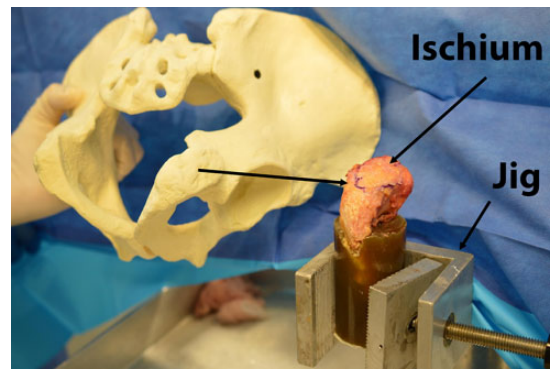
Figure 1. Cadaveric dissection demonstrating the testing setup for hamstring load to failure on a right ischium. A Sawbones model of the pelvis is included to facilitate 3-dimensional understanding of the position of the bone.

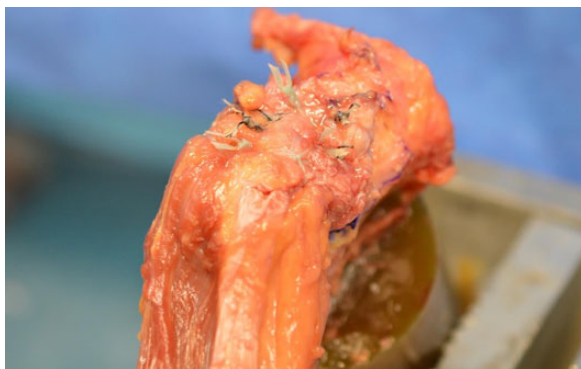
Figure 2. Cadaveric right ischium demonstrating the all-knotted technique (3 anchors) for hamstring repair.

Three 5.5-mm Corkscrew Anchor AK Repair. After detachment of the proximal hamstring insertion site, a 4.5-mm spade drill tip was utilized to drill 3 anchor tunnel sites perpendicular to the tendon insertion site, and these were subsequently tapped in all specimens. A fully threaded double-loaded 5.5 mm-diameter \times 14.7 mm-long anchor (BioComposite Corkscrew; Arthrex) was then inserted into each of the tunnel sites. The suture material consisted of a 1.3 mm-wide ultra-high molecular weight polyethylene nonabsorbable suture (SutureTape; Arthrex). Previous marking of the bone-tendon interface with indelible blue marker allowed us to reapproximate our repair in an anatomic fashion. One limb of each suture pairing was run through the tendon in a Krackow running-locking fashion, and its matching limb was simply passed just proximal to the Krackow pattern in a deep to superficial trajectory to allow the tendon to slide and reduce to its bony insertion site along this suture strand. This was performed at the distal 2 anchor sites before completing the repair with the proximal suture anchor, all with the identical technique (Figure 2).

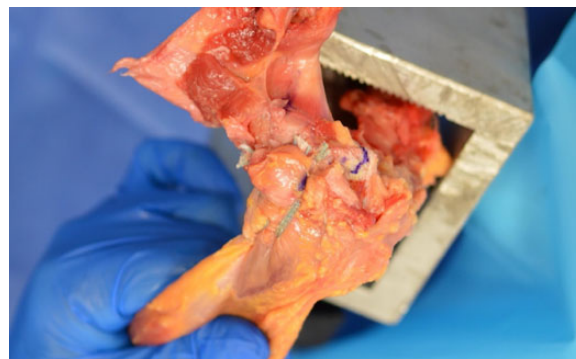
Figure 3. Cadaveric right ischium demonstrating the all-knotless technique (4 anchors) for hamstring repair.

indelible blue marker allowed us to reapproximate our repair in an anatomic fashion. Utilizing first the No. 2 FiberWire, 1 limb of each suture pairing was run through the tendon in a Krackow running-locking fashion for 4 passes, and its matching limb was simply passed just proximal to the Krackow pattern in a deep to superficial trajectory to allow the tendon to slide and reduce to its bony insertion site along this suture strand. The 4 FiberTape suture strands were then passed in a simple deep to superficial manner, through the tendon, and crossed in a bridging pattern before fixating along with the FiberWire sutures in a double-row fashion utilizing swivel lock anchors (Figures 3 and 4).

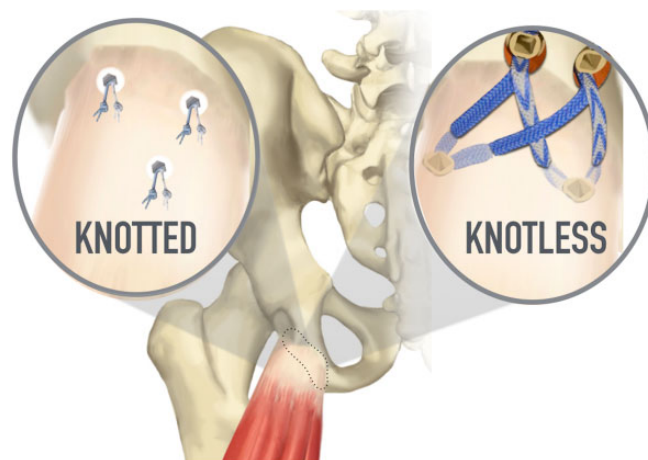
Figure 4. Schematic representation of the all-knotted and all-knotless configurations used in this cadaveric study.

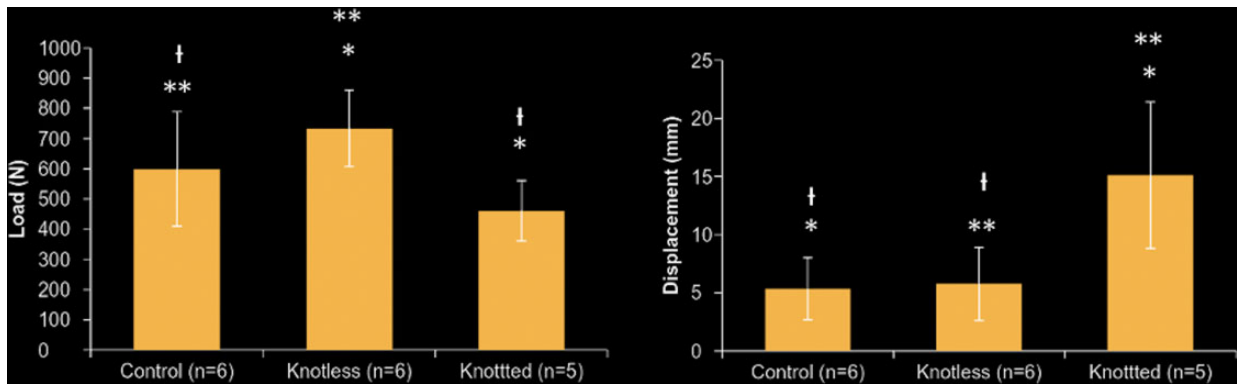
Figure 5. Bar graphs demonstrating the load (left) and displacement (right) of the control (noninjured) group, all-knotted repair repair group, and all-knotless repair group. For the load bar graph: * $P = .024$, ** $P = .248$, and † $P = .140$. For the displacement bar graph: * $P = .005$, ** $P = .005$, and † $P = .866$.

All specimens survived the cyclic loading phase of the testing protocol, and failure was observed during maximal loading. The AS suture anchor construct failed at the highest mean maximal load of the 3 groups (767.18 ± 93.50 N), including that for the intact tendon group (750.58 ± 172.22 N). There was no statistically significant difference between the AS and intact tendon groups ($P = .248$); however, there was a statistically significant difference in the mean load to failure when the AS construct was compared with the AK technique (549.56 ± 20.74 N) ($P = .024$). Displacement measurements of both the AS group (5.75 ± 3.13 mm) and the intact tendon group (5.33 ± 2.66 mm) were significantly less than that of the AK group (15.12 ± 6.30 mm) ($P = .005$) after cyclic loading. There was no statistically significant difference between the control and AS groups ($P = .866$) (Figure 5).

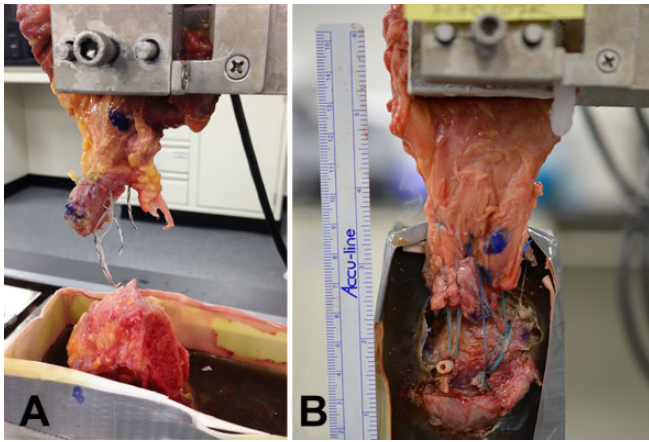
Figure 6. Failure in the (A) all-knotted and (B) all-knotless constructs at the suture-tendon interface and at the musculotendinous junction, respectively.

The most common mode of failure in both of the repair groups was at the suture-tendon interface, whereas the intact tendon group most frequently failed via avulsion of the tendon from its insertion site. The AK configuration failed at the footprint in 4 of the 5 specimens and via suture anchor pullout in the fifth specimen. The AS construct failed most frequently at the musculotendinous junction, with 5 of the 6 specimens failing at this location, with the

remaining failure observed directly from the footprint (Figure 6).
